TerraSAR-X STARING SPOTLIGHT MONITORING OF A HIGHWAY BRIDGE IN THE CZECH REPUBLIC (PRELIMINARY RESULTS)

Ivana Hlaváčová⁽¹⁾, Jan Kolomazník⁽²⁾, Lena Halounová⁽¹⁾

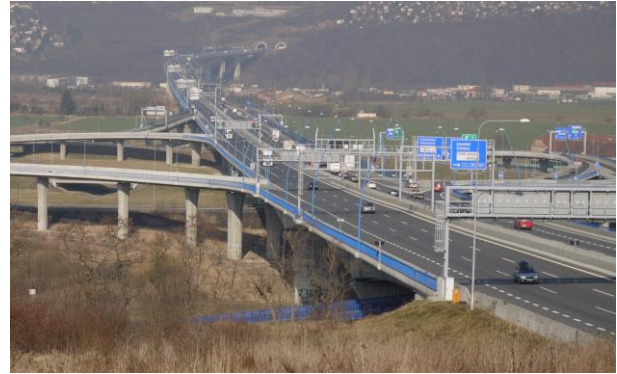
Figure 1. The area of interest (AOI)

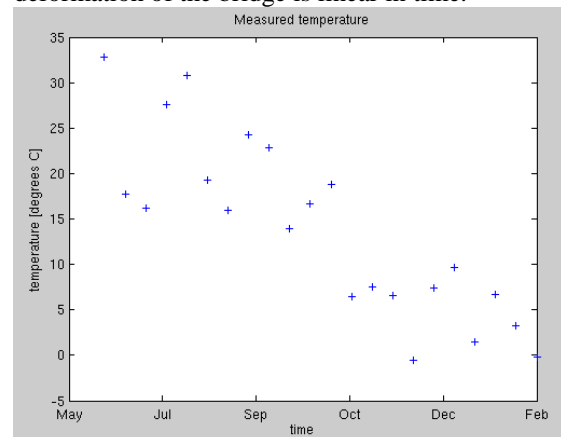
Figure 2. The measured temperature

As significant temperature effects are expected (high resolution, steel-concrete construction), the temperature is monitored at a nearby bridge (approx. 50 m away from the estacade). Unfortunately, up to now, the temperature is heavily dependent on the time (see figure 2), their covariance is -0.86, therefore recognition of the linear deformation signal and the thermal dilation is not stable/possible. In addition, it is never certain that the deformation of the bridge is linear in time.

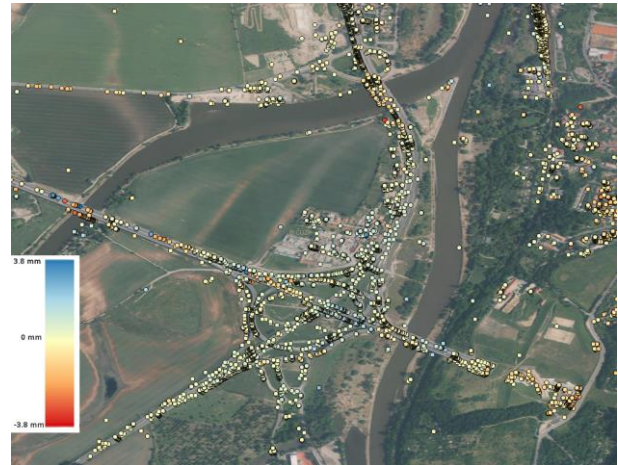
Figure 6. Adjustment residues (in LOS) for June 19th, 2014 (acquisition n. 1). Processed in SarPROZ.

Figures 6, 7, 8 displays adjustment residues for few acquisition dates in space. Please note that the residues of the reference point are not zero (due to software) and the position of the reference point is the same as in figure 4. It is obvious in figures 6-8, that the residues have a similar manner to the thermal dilation coefficient (displayed in figure 4), so it is possible that the thermal dilation is nonlinear w.r.t. temperature, or that the temperature measurements are not accurate enough.

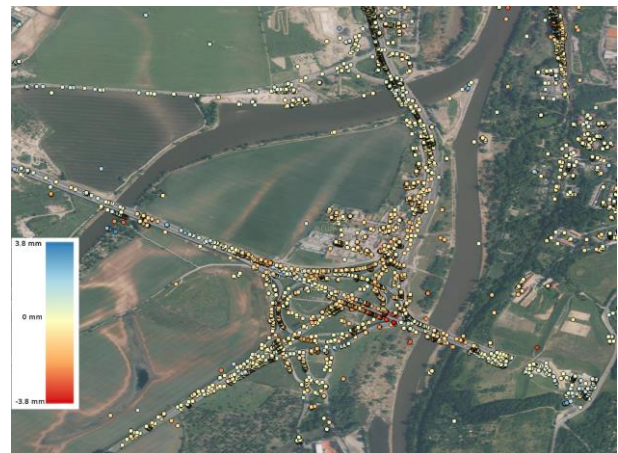
Figure 7. Adjustment residues (in LOS) for July 11th, 2014 (acquisition n. 3). Processed in SarPROZ.

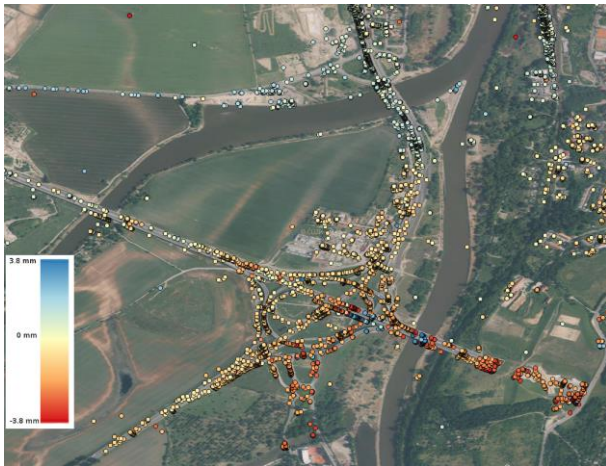
Figure 8. Adjustment residues (in LOS) for July 22nd, 2014 (acquisition n. 4). *Processed in SarPROZ.*
